# **DEVELOPMENT OF SILICON NITRIDE OF IMPROVED TOUGHNESS**

**by J.J. Brennan**

**October 2, 1979**

**UNITED TECHNOLOGIES RESEARCH CENTER**

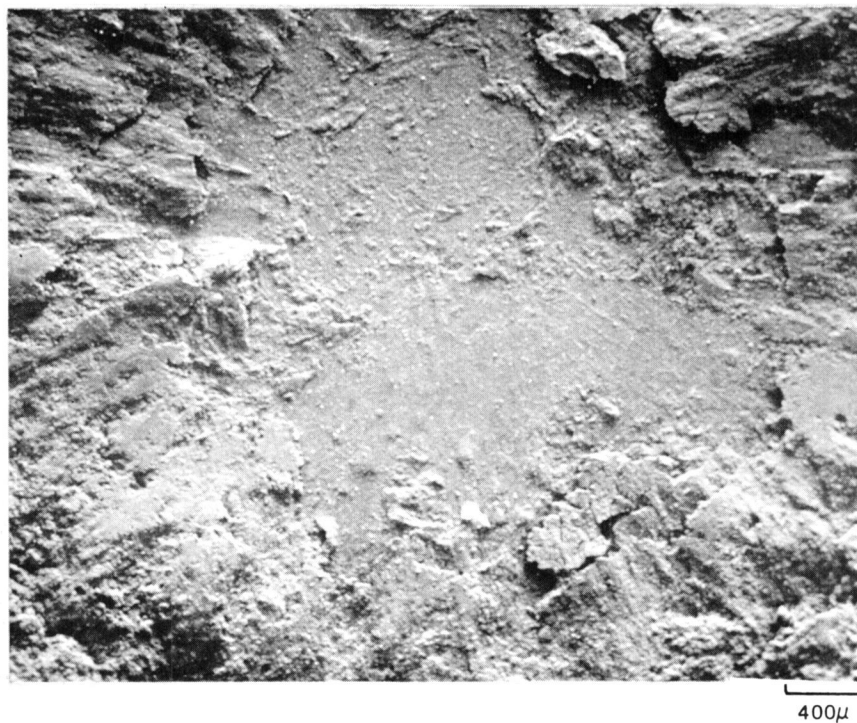
POINT OF IMPACT THROUGH A-200 RSSN LAYER DOWN TO THE HPSN SUBSTRATE  
FOR A STEEL SPHERE TRAVELING AT 300M/SEC

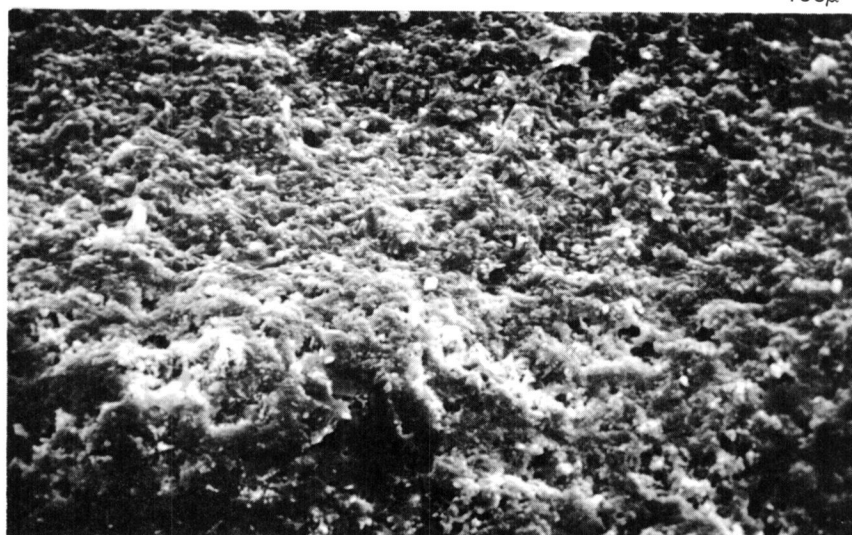
FRACTURE SURFACE OF NC-132  $\text{Si}_3\text{N}_4$  WITH -325 Si LAYER (NITRIDED AT  
MAXIMUM TEMP. OF 1375°C FOR 24 HRS.)

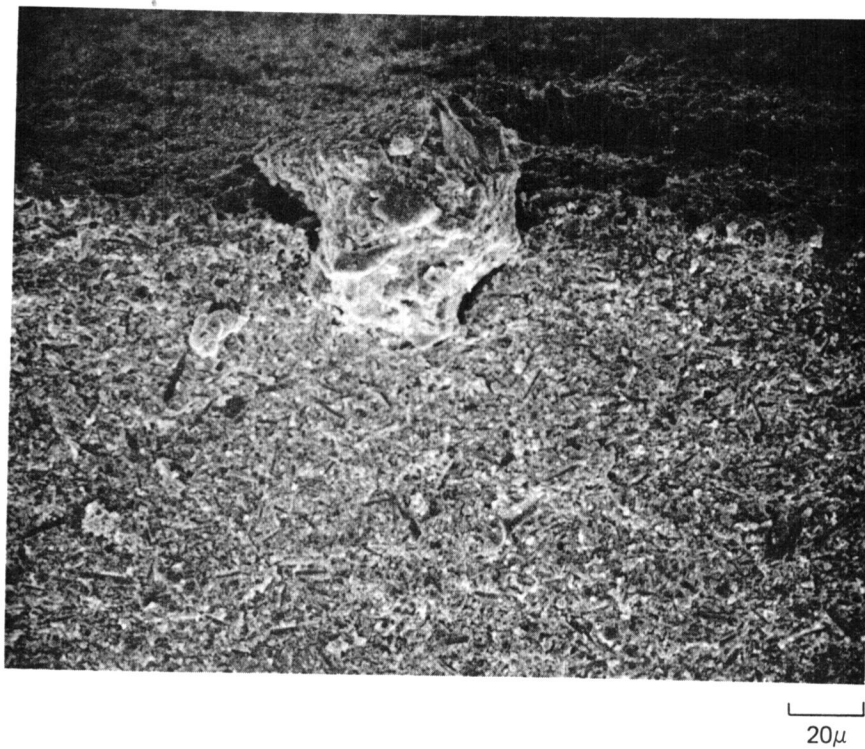
FRACTURE ORIGIN OF NCX-34  $\text{Si}_3\text{N}_4$  WITH LOOSE -100, +200 Si PARTICLES  
ON THE SURFACE, NITRIDED TO 1375°C, 60 HRS,  $\text{N}_2$

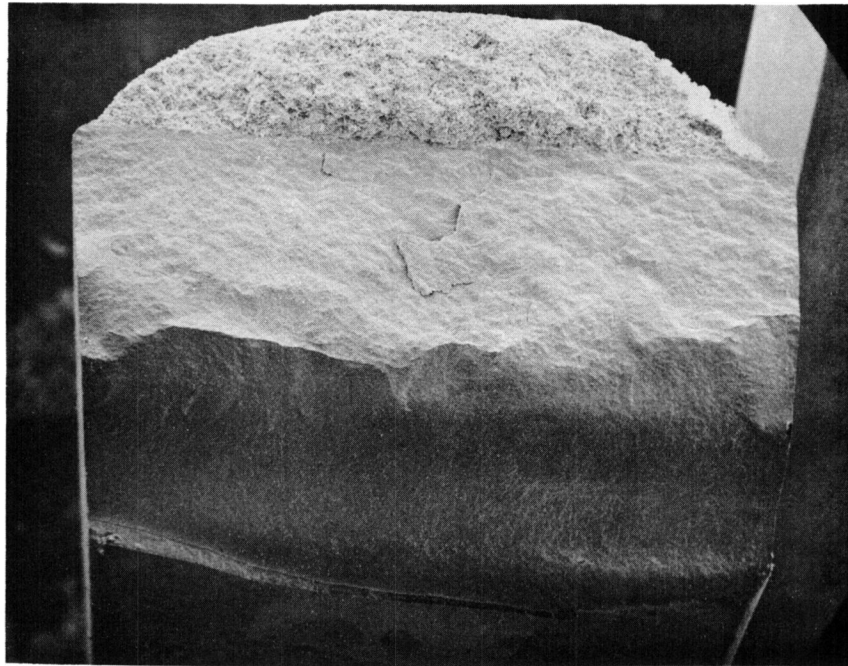
FRACTURE SURFACE OF -325 Si (98%) RSSN LAYER ON NCX-34 Si<sub>3</sub>N<sub>4</sub>,  
NITRIDED IN 96% N<sub>2</sub>/4% H<sub>2</sub> TO 1375°C, 60 HRS

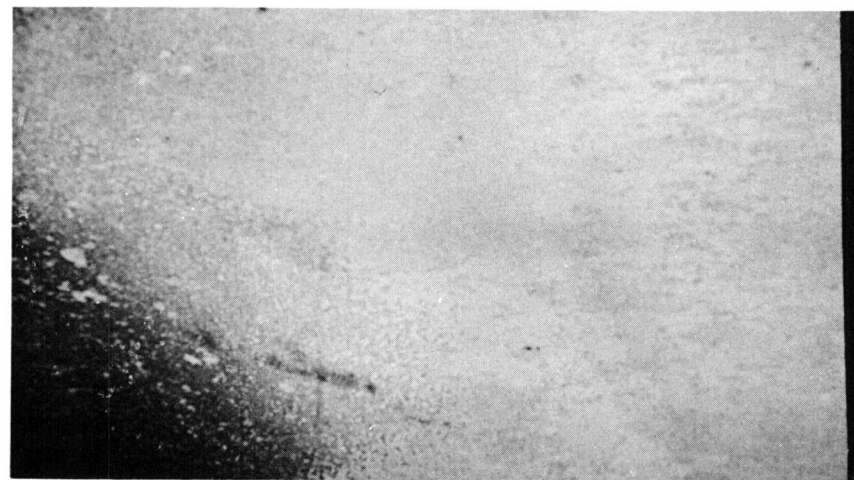
SEM OF NC-132  $\text{Si}_3\text{N}_4$  EROSION SAMPLE TESTED AT 1370°C, 5 HRS.
